CYCLONE CATARINA: DAMAGE AND VULNERABILITY ASSESSMENT

Emerson Vieira Marcelino¹
Isabela Pena Viana de Oliveira Marcelino¹
Frederico de Moraes Rudorff¹

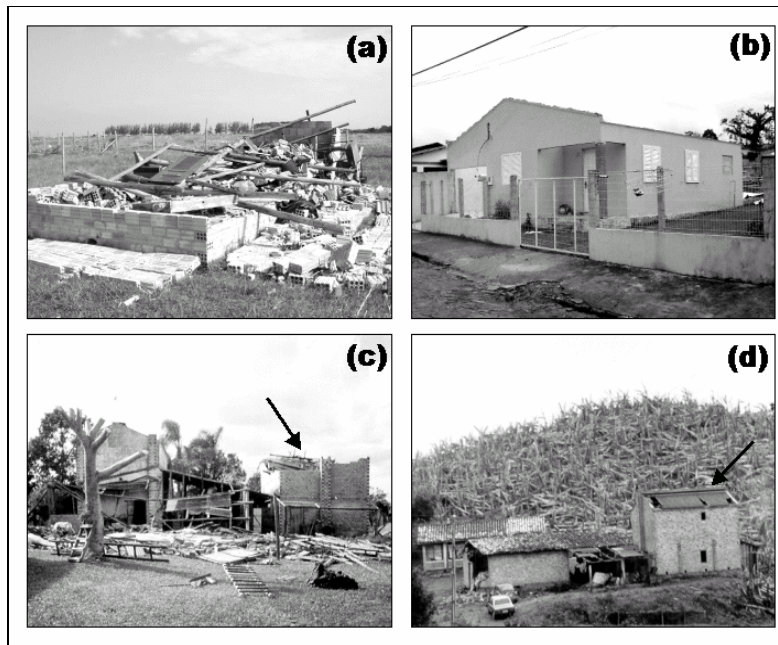
Figure 2 shows the types of damages over edifications frequently observed at the different intensity classes. At the Very High intensity class the pressure from strong winds caused the collapse of many houses, as can be observed at Figure 2a. At the High intensity class there were several cases of roof failure, as can be observed at Figure 2b. At the Medium intensity class there were many roof failure and collapse of tobacco warehouses (Figure 2c). At the Low intensity class there were affected mainly agricultural fields as can be observed at Figure 2d, where the banana field was totally destroyed, and there was just minor roof material failure at an edification located at that site.

Figure 2 – Examples of the damage intensity classes: (a) Very High class; (b) High class; (c) Medium class; and (d) Low class.

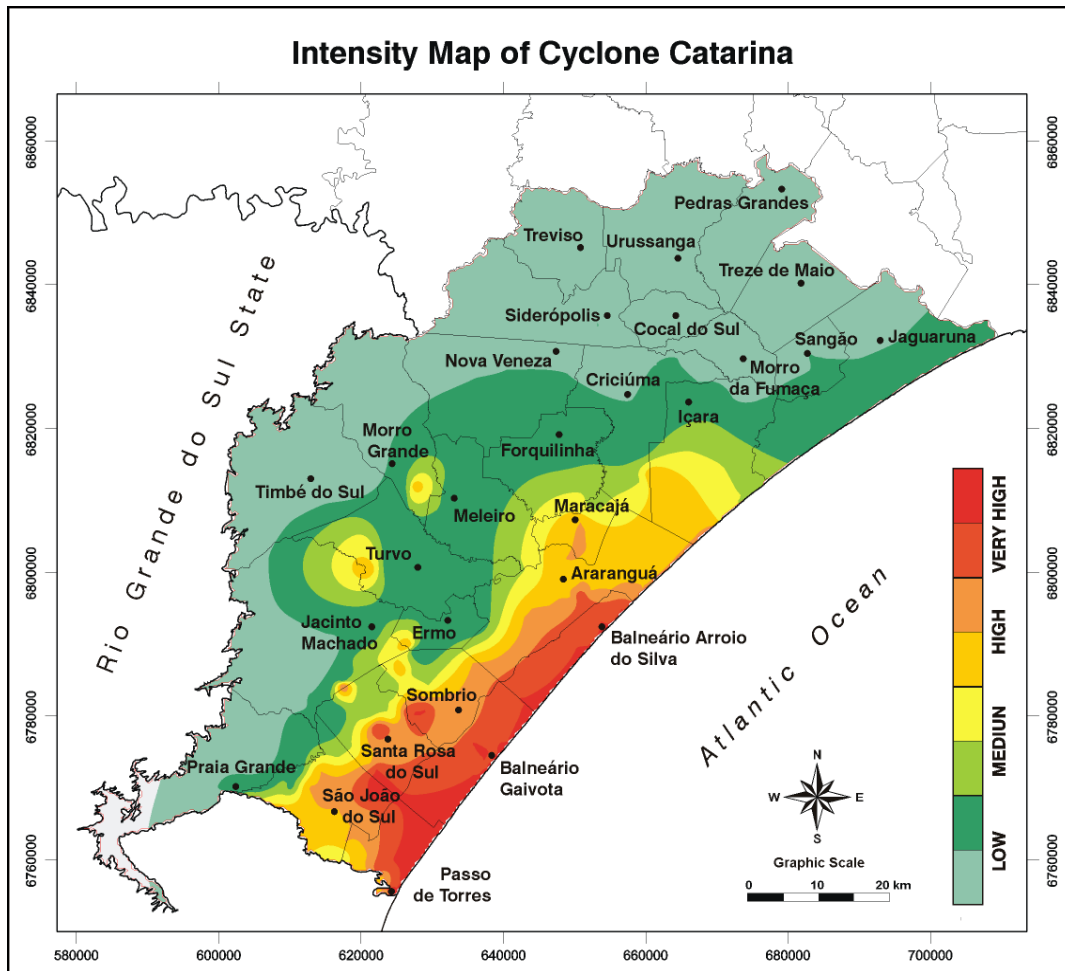
Figure 3 shows the intensity map of Cyclone Catarina, which is directly related to the damage classes, established in Table 1. Areas in reddish were the most impacted by hurricane winds, covering almost the entire municipalities of Passo de Torres, Balneário Gaivota, and Balneário Arroio do Silva. At this region, according to Marcelino et al. (2004), the winds achieved around 120 km/h at the first eye wall and around 180 km/h at the second eye wall. The intensity of the cyclone diminished as it moved from the coast towards the steep slopes of Serra Geral, showing a radial destruction pattern. At the coastal plain, near Serra Geral, there were verified some points with a greater destruction than the surrounding area due to the speedup effect of land surface elevations.

Figure 3 – Intensity map of cyclone Catarina.

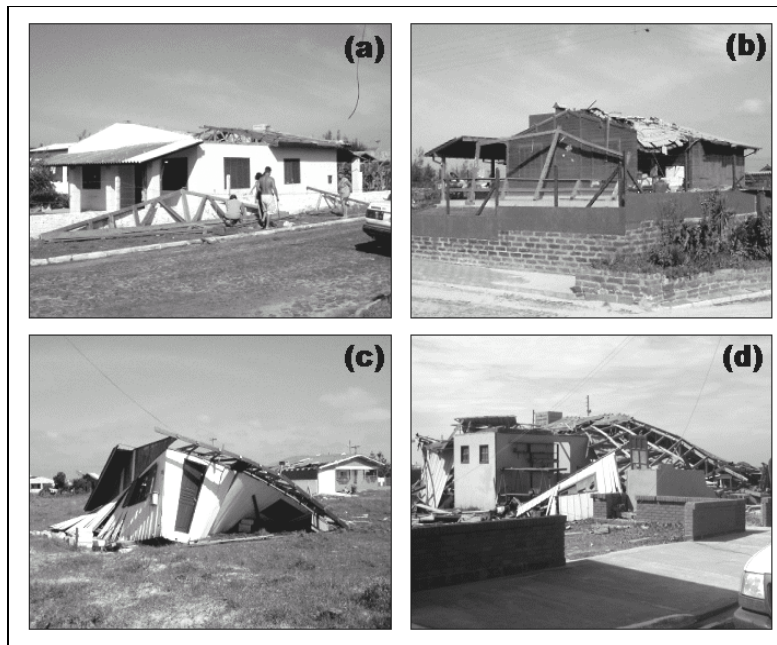
The landfall area was severely affected, and the damages were more intense over the communities closest to the coast. The damages observed were diverse, ranging from failure to total collapse of roofs and houses (Figure 4).

Figure 4 – Types of damages caused by wind on residences: (a) total roof failure; (b) partial roof failure of a non-engineering wood house; (c) total destruction of a non-engineering wood house; and (d) total collapse of a masonry house.

Thus, most of the damages verified over the landfall area were occurred on non-engineering wood and brick houses. These damages were considerably high, because these structures are constructed with low resistance material and structure. The brick houses usually did not have plaster, beams and columns, resulting in a fragile structure with a poor tie down between roof and walls.

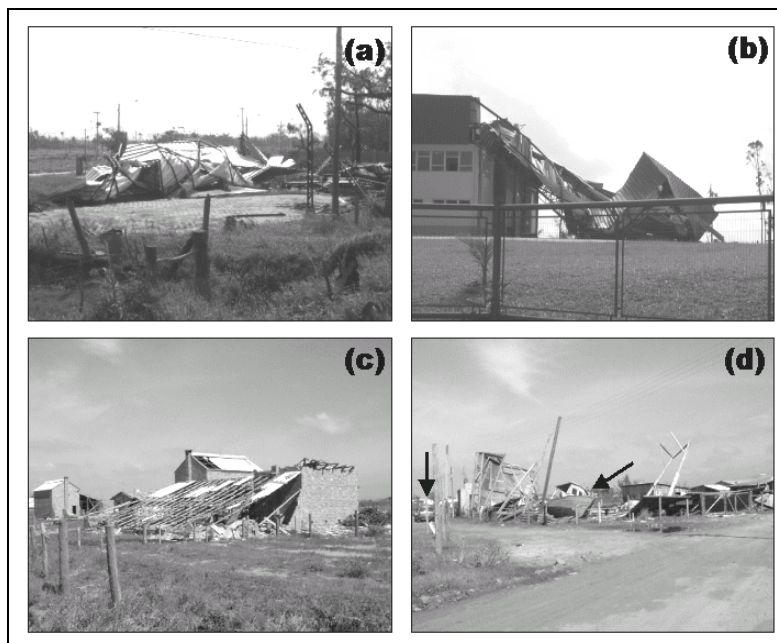
Many sheds also suffered from total and partial collapse (Figure 5a and 5b). At the rural area, warehouses, which present a type of construction similar to brick houses, were most affected structures (Figure 5c).

At Passo de Torres, many shipyards collapsed, due to the poor wood structure quality and the high walls (6 to 8 m), highly vulnerable to wind pressure (Figure 5d). Besides the widespread roof damage at this municipality (Figure 6a and 6b), it was observed that a non-engineering wood house situated at the southern margin of the Mampituba River at Torres Municipality (Rio Grande do Sul State) was blown approximately 50 m across the river, ending up at the northern margin at Passos de Torres Municipality, Santa Catarina State (Figure 6c).

Figure 5 – Types of damages caused by wind force on sheds: (a and b) total and partial collapse of metallic sheds; (c) partial collapse of tobacco warehouses; and (d) total collapse of a shipyard.

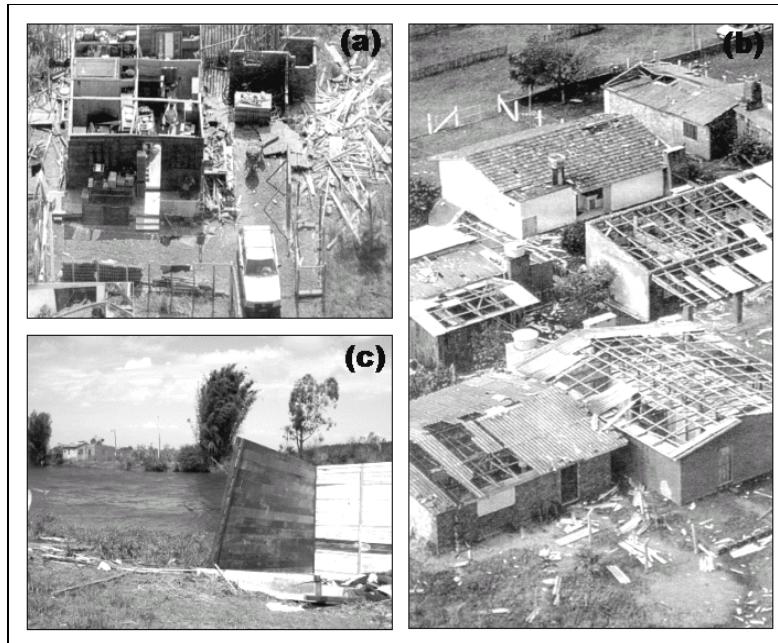
Figure 6 – Types of damages caused by wind force on edifications: (a and b) widespread roof failure; and (c) non-engineering wood house blown across the Mampituba River, divisor between the Rio Grande do Sul and Santa Catarina States.

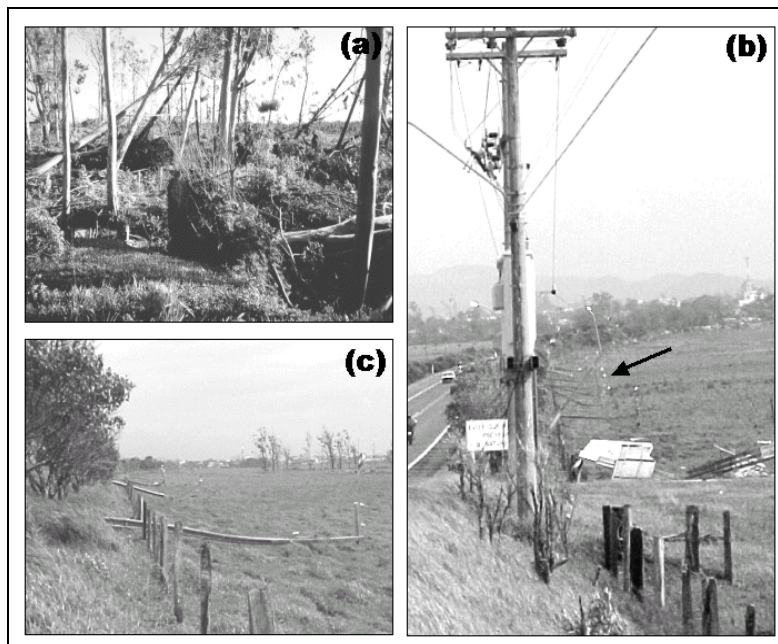
Another significant damage occurred on forestry, with trees toppled and broken (Figure 9a). Power transmission lines were also highly affected. A sequence of approximately 40 light poles toppled at the road connecting Balneário Gaivota to Sombrio municipalities (Figures 9b and 9c) causing blackout, communication problems, and interruption of water supply.

Figure 9 – Severe destruction on forestry (a) and power transmission lines (b and c).

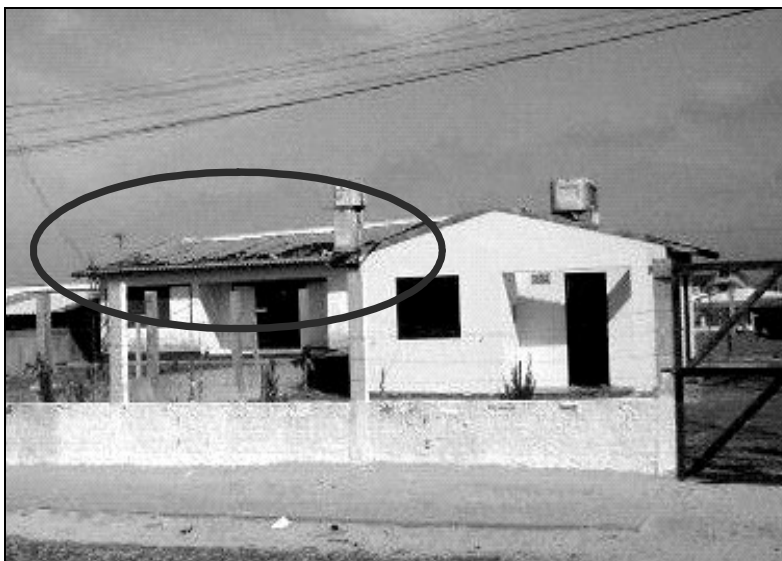
The roof material failure was directly associated to the vulnerability of the different types of tiles and the roof shapes and arrangements in relation to wind direction. The most vulnerable roofs were those covered by 6 mm concrete and asbestos fiber (CAF) tiles. The vulnerability diminished at roof covered by 8 mm CAF tiles. However, the damages were significantly lower at the houses covered by clay tile, regardless of the roof positions and structures.

Regarding to the roof shape and arrangement, the portion facing the highest wind pressure is a fragility point that can trigger its failure and/or collapse. For example, at Figure 10, the most vulnerable roof shape type is represented at example I, with a veranda 2 to 4 m wide. The wind, as it hits the wall, it exerts great pressure, moving upwards and forcing the roof structure. The less vulnerable type is represented at example V, with a cornice (70 to 80 cm), which faces a lower wind pressure.

This can be better explained by using Figure 11 as an example. Both houses have the same type of tile (6 mm CAF tiles), but with roofs arranged differently in relation to the wind direction. At the house highlighted by the black circle (example V), there was just some roof material failure. However, at the house besides (Example I) the whole roof structure collapsed and was thrown approximately 15 m away, due to the presence of a veranda.

Figure 11 – Vulnerability example associated with roof shapes.
