**GlobeSAR 2 Mid-Term Symposium:**  
*"RADARSAT Applications in Latin America"*  
Primer Simposio GlobeSAR 2:  
*"Las aplicaciones de RADARSAT en América Latina"*

**Preliminary Evaluation of Radarsat Fine Mode Image to Map Linear Features in Area of Hydrocarbon Microseepage, Tucano Basin, Brazil (GlobeSAR-2, Project Brazil - 15)**

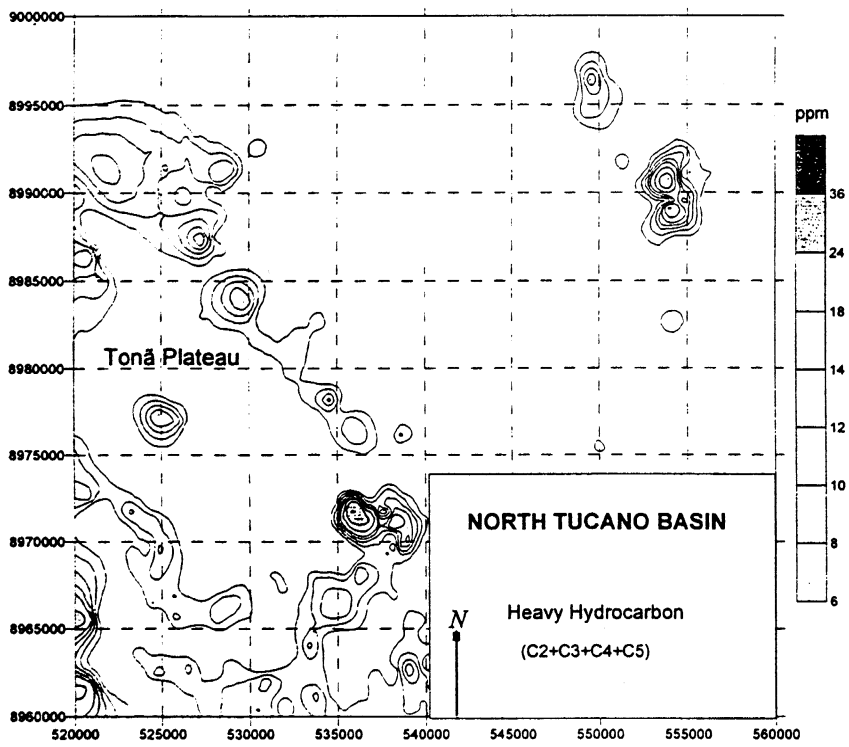
**Figure 2. Contour map showing distribution of heavy hydrocarbon content in the study area.**

As part of a regional exploration program, the Brazilian Oil Co. (Petrobras) carried out a geochemistry soil gas survey in the northern part of the Tucano basin, with 633 sample points for methane, ethane, propane, butane and pentane, in a surveyed area of approximately 1,300 km<sup>2</sup> (Babinski *et al.*, 1993). Heavy hydrocarbon content (ethane to pentane) yielded an arithmetic mean value of 4.98 ppm, which was assumed as the regional background (methane was not included due to its possible biogenic origin). Figure 2 is the contour map showing the distribution of heavy hydrocarbon content (above the background level) in the study area. According to these data, several hydrocarbon microseepage anomalous targets occur mainly surrounding the Tonã plateau.

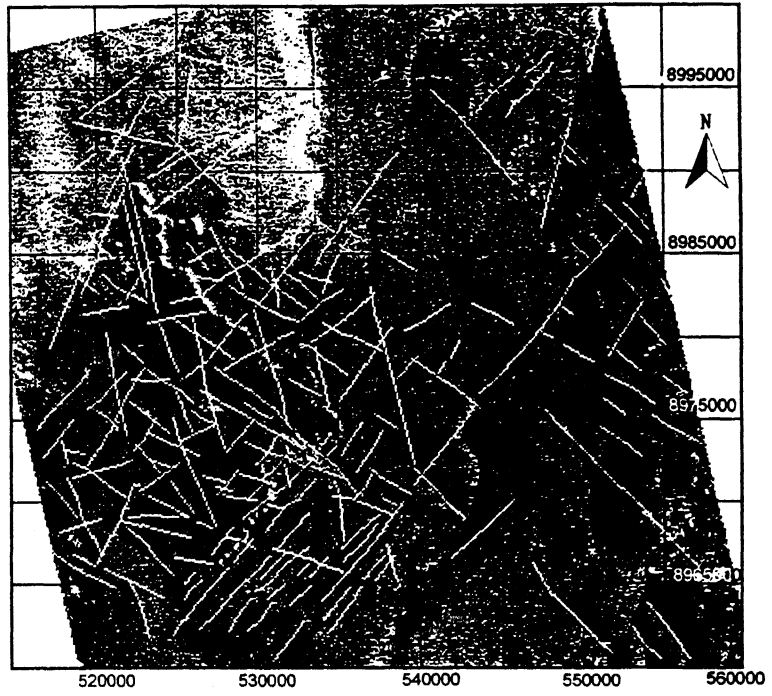
**Figure 4. Radarsat image and interpreted lineaments.**

Interpreted lineaments, assumed as representing fractures lines and faults, are superimposed on the same image, in Figure 4. It was very difficult to confirm the geologic nature of the interpreted lineaments during field check, due to the widespread presence of regolith in the area. However, in a few places it was possible to confirm the presence of fractures and faults related to the photointerpreted lineaments.

As showed in Figure 4, the region of the Tonã plateau has a higher density of lineament compared with the rest of the study area. Comparison with Figure 5 shows a very good spatial correspondence between the distribution of lineaments and anomalous areas of hydrocarbon microseepage. According to our interpretation these lineaments, representing fractures lines and faults, constituted the primary conduits for the migration of hydrocarbon and associated fluids to the surface.

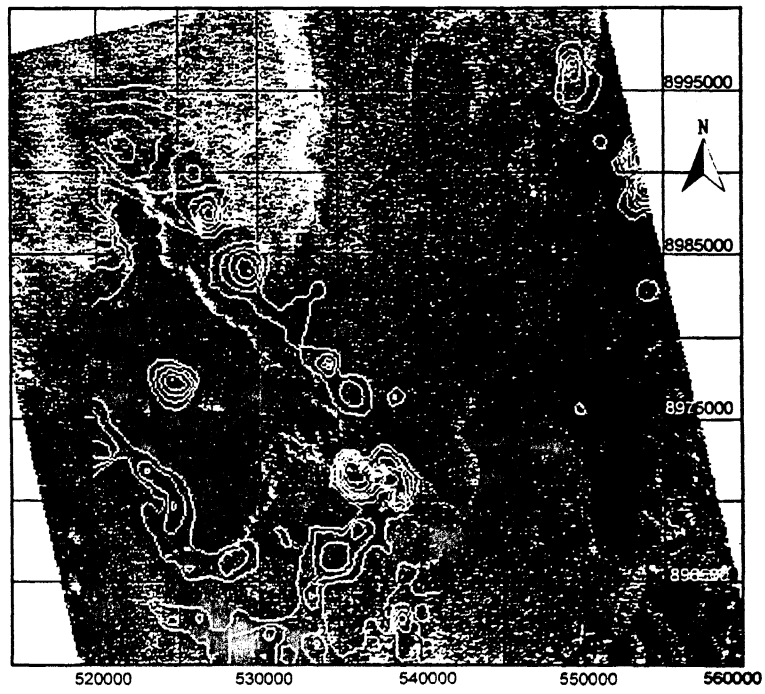
**Figure 5. Radarsat image and anomalous areas of hydrocarbon microseepage.**

Most of the gas soil anomalies are distributed along the border zones of the Tonã plateau. This fact suggest that the cherty limestones that constitute the plateau work as an effective seal to prevent the vertical migration of the fluids, which escaped in the contact zone with the soft sandstones of the Marizal Formation. Only one soil gas anomaly occurs over the Tonã plateau, just in the center of the circular collapsed structure mentioned previously. In this particular case, the collapse phenomenon seems to disturb the cherty limestone seal, allowing the vertical migration of the hydrocarbon in that site. These facts suggest that the hydrocarbon reservoir responsible for microseepage areas is located just under the Tonã plateau.
